EARTHQUAKE DAMAGE INTENSITY RELATIONSHIP FOR RESIDENTIAL HOUSES IN WEST SUMATRA

Febrin Anas Ismail^{*)}, Abdul Hakam, and Fauzan

Civil Department, Engineering Faculty, Andalas University, Padang 25163, Indonesia

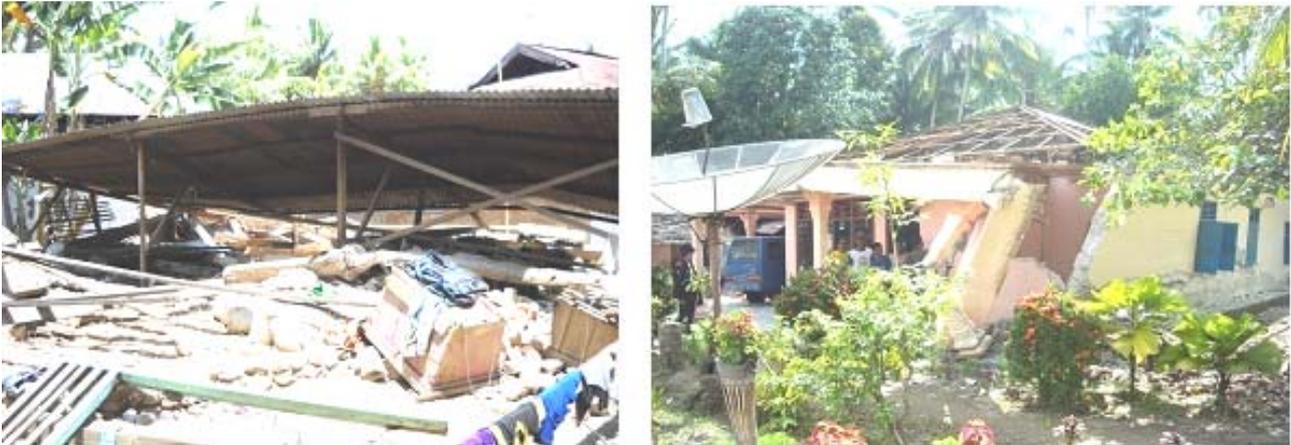
Figure 3. A Heavily Damage Houses

Determination of the extent of building damage was done by visual observation. Based on the visual observation, the affected buildings can be classified according to three level of damage which follows the Indonesia government criteria. There are three initial given for the damaged building: RB for a heavily damaged building/house, RS for a house with a level of moderate and RR for the slightly damaged house. For the example, the condition of a house that referred to be suffering from heavily damage is shown in Figure 3.

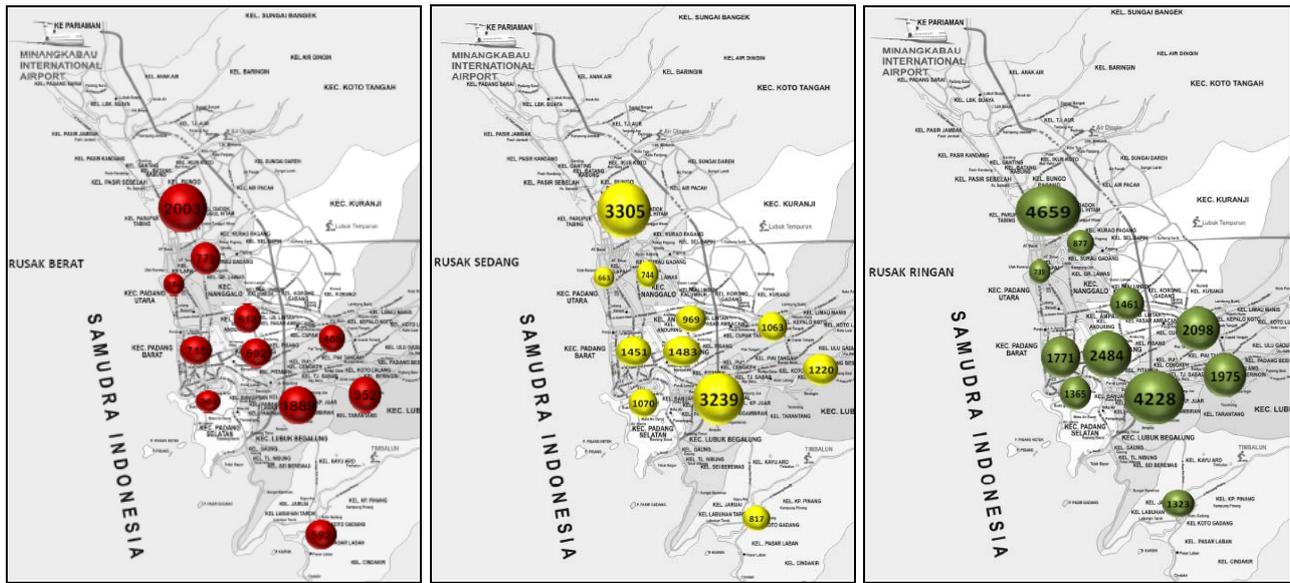
Figure 4. Damage Houses in Padang

Padang city consists of 13 districts involving 104 villages. There are 116,476 houses scattered in the city of Padang. The survey recorded at around 37,587 houses were heavily damaged, 38,485 and 40,406 suffered moderately and slightly damage respectively. The data is very important information for Government to do the next steps in implementation of rehabilitation and reconstruction of buildings after the earthquake in West Sumatra and Padang in general.

This paper shows the plot results of survey of the damage homes in Padang. The results are displayed in the term of map which is divided by districts in the city. Figure 4a, 4b, and 4c show damage to the residential

houses with the category of heavily, moderate and slightly for the city. In every figure, the number that indicated the damaged houses is displayed in. The size of the bubble also presents of the ratio damage in each district. It seems that there is quite diverse spread of damage to the house. However this spreading data may be figuring the seismic ground condition that has been reported by Sengara *et al.* in 2009 [8] (Figure 5).

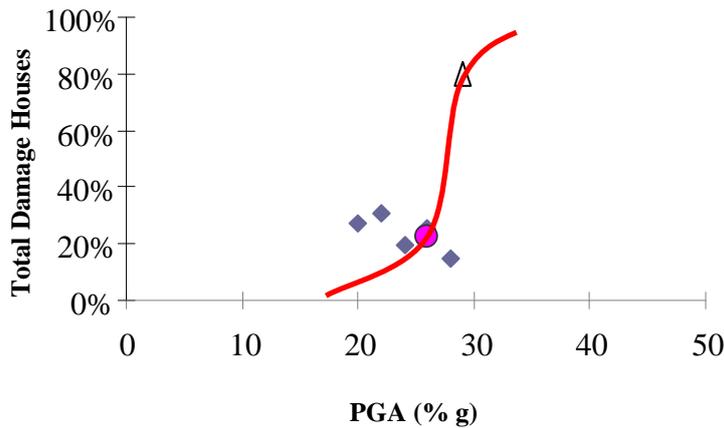
Figure 6. Damage and Earthquake Acceleration, Padang in Average (●), Padang in Districts Area (◆), Pariaman in Average (△)

Furthermore, by dividing the area based on the level of earthquake intensity, it can display a graph of the distribution of damage to houses related to the peak ground acceleration. In the Figure 6 can be seen that there may relationship between the percentage the earthquake intensity with the distribution of the damage. In the figures also plotted the percentage of damaged houses in the city of Pariaman where located only a teens kilometres from the epicentre. The straight line curve is built in the figure to fit the relation between the damage level and the earthquake intensity in West Sumatra.

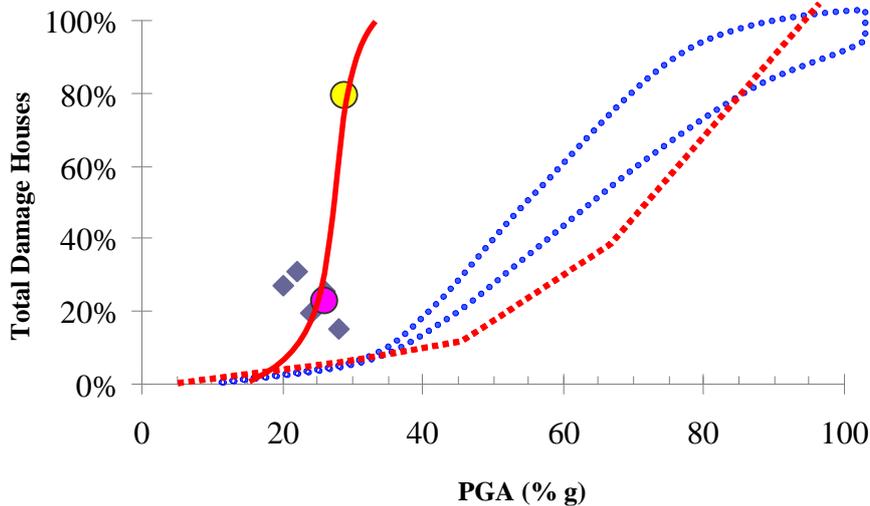
Figure 7. Earthquake Damage Intensity Relationship, West Sumatra (—), Sengara, 2011 (●●●), Birss, 1985 (■■■)

The results of Birss and Sengara both for brickwork structures then are plotted together with the results of this study (Figure 7). It can be seen that the predicted curves given by the other authors give over estimate to the strength of the brick masonry houses in West Sumatra.

In reality the quality of residential houses in West Sumatra depends three main factors that are: a) The quality of materials, such as the strength of the bricks; b) The process of the construction which including the skill of the worker and material composition, and c) The detailing of the construction that including the connectivity and dimension of the element of the residential structures.

It can be concluded that the quality of the residential houses in West Sumatra are very poor. The earthquake

intensity to destroy the houses in West Sumatra is lower compared to the New Zealand or the other place in Indonesia.
