HYDROGEN ABSORPTION IN WELDMENTS OF OVERLAID CLADED PRESSURE VESSEL

Abstract

Cracks was found in type 347 stainless steel internal attachment welds of a reactor for a high temperature, and high pressure hydrogen service. One of the possible causes of cracking is low cycle fatigue cracking induced by repetition of thermal stress to embrittled weld metal. Type 347 weld metal loses its ductility by presence of sigma phase and hydrogen.

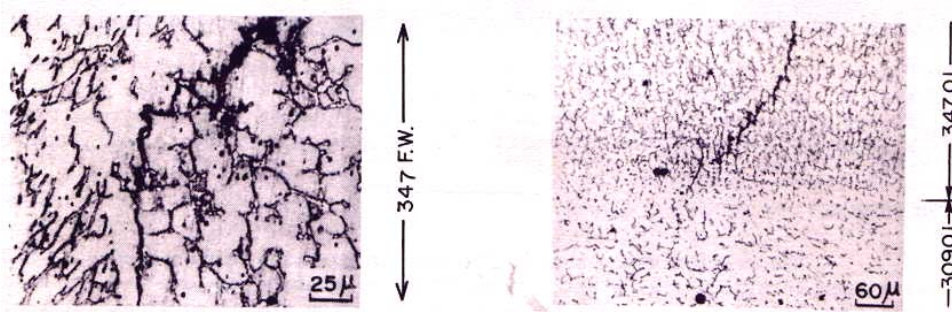
Figure 1. Cracks in internal attachment weldment

Figure 1 shows cracks which were found in a type 347 stainless steel attachment weld of a direct desulfurization reactor operated at hydrogen gas pressure of approximately 13.70 MPa and at temperatures of 320 to 455°C. The cracks originated in type 347 fillet weld which attached a type 321 stainless steel block to the inner surface of the reactor which was weld overlaid by type 310 and 347 steels. Most of the cracks propagated through the type 347 weld overlay and terminated at the boundary of type 347 and 310. The cracks were associated with delta ferrite and sigma phase in type 347 weld metals. And the cracked weld metals occluded high amount of hydrogen.

It is clearly shown in Figure 1, that the cracks show straight propagation along with dendritic structure in type 347 stainless steel weld metals without any noticeable branching that appears in the stress corrosion cracking process. From this it may indicated that the cracking has close relation to the ductility loss of the weld metals due to hydrogen absorption.

Preventive measure for the cracking. It is recognized from Equation (2) that a small strain range and large tensile ductility are desirable for improved life (N). Strain range can be kept low by decreasing thermal stress levels and avoiding stress concentrates. Internals made of a Cr-Mo steel and weld overlaid by stainless steel (instead of solid stainless steel internals) can reduce thermal stress [4]. The corner radius on internal attachments should be smooth and as large as possible to minimize stress concentration. Internals attached to the reactor wall should be designed to allow easy access for welding in order to minimize weld defects. Crack arrest at the boundary between the type 309 and type 347 suggests that a lighter construction should be always considered in designing internal attachments

Through various studies carried out, the following results are obtained: (1) Low cycle fatigue type cracking associated with loss of tensile ductility due to sigma and hydrogen is considered as a possible cause of the cracking; (2) In order to prevent the cracking, control of the amount of sigma phase in type 347 weld metals and decrease of the strain amplitude imposed to the internal attachment weldments are suggested.

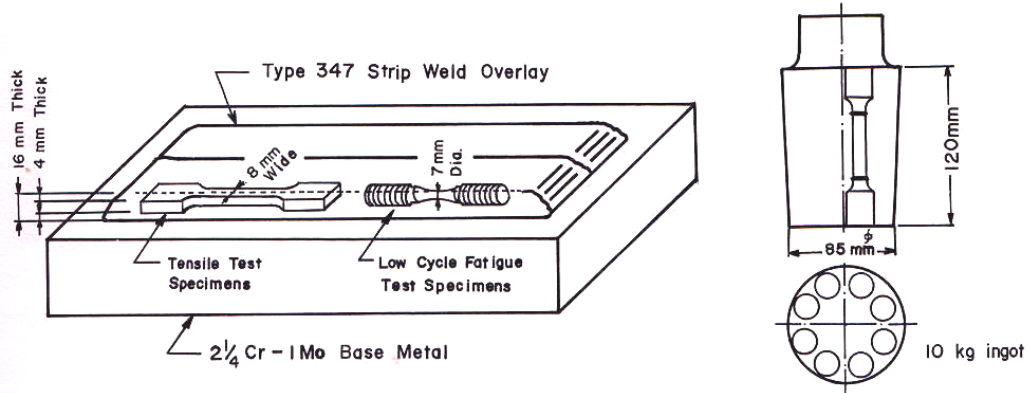
Figure 2. Location of specimens

Type 347 weld metals containing various amounts of delta ferrite are used for the major portion of this investigation. And the other austenitic weld metals and casting are also used. All of the weld metals are prepared by strip weld overlay on the 100 mm thick 2 1/4Cr-1Mo steel forging.

The cast test blocks used are 12 kg ingots made by vacuum induction melting. Test blocks and location of test specimens are presented in Figure 2.

specimens with 7 mm minimum diameter were taken from the overlaid weld metal as shown in Figure 2. With diametral strain controlled, zero-tension low cycle fatigue tests were conducted with frequencies of 5 to 10 cycles per minute.

The initiation of fatigue cracks was investigated using polished flat specimens (Figure 2). Microscopic observation revealed that minute cracks formed after only a few cycles at stresses lower than the yield strength. A specimen taken from type 347 weld metal with 15% as-welded ferrite, heat treated and hydrogen charged was stressed repeatedly from 0 to 0.92 times the yield strength. The crack was found in a sigma rich area and outlined the sigma phase. It appears cracking occurs when the sigma phase separates from the gamma matrix.

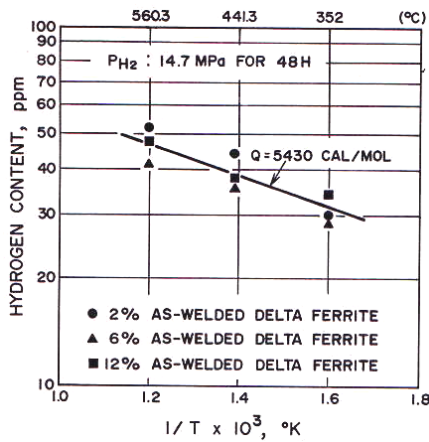
Figure 3. Effect of temperature hydrogen absorption by Type 347 weld metal

Results are shown in Figure 3 and 4. According to Sievert's law, hydrogen absorption or solubility in metals is dependent on the temperature and partial pressure of hydrogen gas, and their relation in given as the following equation.

It is clear in Figure 3 and 4, hydrogen absorption in type 347 weld metals is also in good agreement with Sievert's law, that is absorbed hydrogen content is strongly affected by hydrogen pressure and temperature. But effect of delta ferrite content, up to 12%, on hydrogen absorption of type 347 weld metals is not so clear.

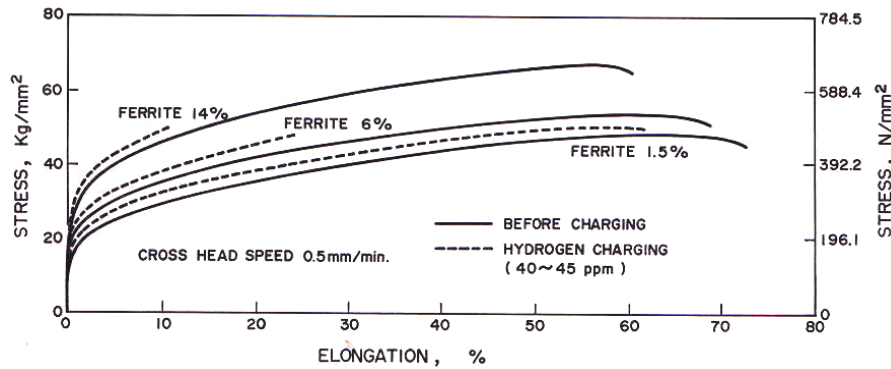
Figure 5. Stress-strain curves of Type 347 castings with different delta ferrite

Stress-strain curves of type 347 steel. Figure 5 shows stress-strain curves of type 347 castings with different delta ferrite content before and after hydrogen charging. Type 347 castings are embrittled by absorption of 42 to 47 ppm hydrogen. Degree of hydrogen embrittlement in

type 347 casting depends on delta ferrite content. After hydrogen absorption, the yield strength of type 347 casting is higher than that of hydrogen free casting.

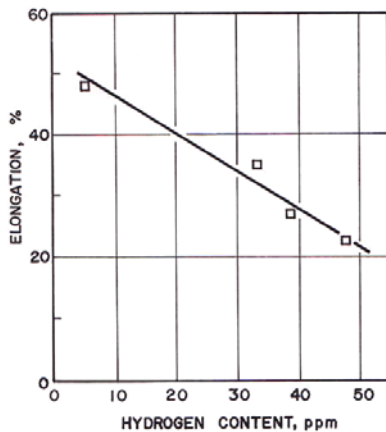
Figure 6. Effect of hydrogen content ductility of a type 347 weld metal; As-weld with 13% delta ferrite

metal specimens. The as-weld metal with 12% delta ferrite was charged with hydrogen under a pressure of 14.7 MPa for 48 h at temperatures between 355 to 555°C. The result obtained is shown in Figure 6, and it was found that the elongation decreased linearly with increase of hydrogen content.

In These experiments, weld metal showed about 22% loss of ductility due to 39 to 59 ppm hydrogen. The forging seems to be less sensitive and the casting to be more sensitive than the weld metal.
