SMALL SCALE EXPERIMENT: THERMAL PERFORMANCE COMPARISON BETWEEN FIBER-CEMENT ROOF AND PHOTOVOLTAIC ROOF IN MALANG, INDONESIA

Keywords: electrical power loss, fiber-semen roof, roof integrated photovoltaic, small scale experiment, thermal performance

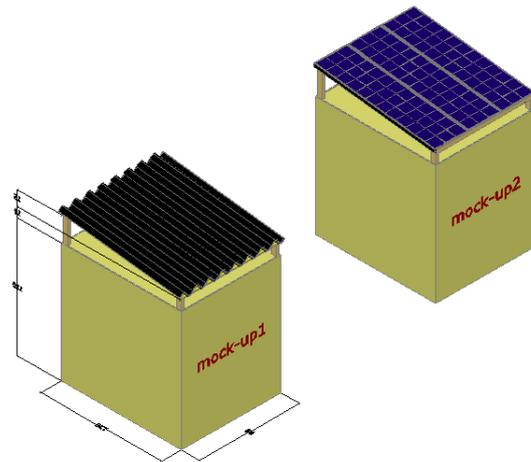
Figure 1. Picture of the Mock-ups

The experiment required 2 mock-ups as test objects: a mock-up room with fiber-cement roof and a mock-up room with photovoltaic modules roof. Mock-up made from fiber-cement was used as a reference because this material is more popular. All mock-ups were made of the same size as follows: length 120 cm, width 99 cm, and height 145 cm. Length and width of the mock-up was decided by practical considerations, following the solar module size. The fiber-cement was equal in size because the size of fiber-cement can be easily customized. Perspective picture and photos of the 2 mock-ups are shown in Figure 1 and Figure 2.

The frames of mock-ups were made from Meranti wood. The areas were covered with 12 mm thick plywood. The top of the mock-ups had space to represent the roof ventilation space. The first mock-up was a mock-up of fiber-cement roof, whose roof was as wide as its plan. The second mock-up was roofed by 3 pieces of photovoltaic modules. Photovoltaic modules used was polycrystalline module M75 with NOCT 25 °C and 8.5% efficiency, the power peak at 750 W/m² sunlight intensity was up to 22.792 Watt and its coefficient of power per temperature = 0.039 W/°C [5].

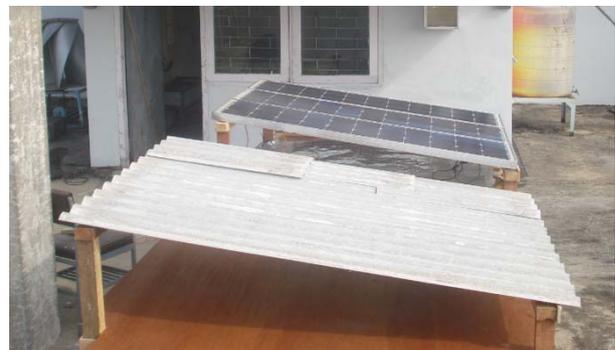
Figure 2. Photo of the Mock-ups

Mock-ups were put on a shadow-free area throughout the day. The positions of mock-ups were also arranged so as not to overshadow each other even though the position of the sun shifted throughout the day. The surface of the roof of each mock-up and the space underneath were mounted with a thermocouple tool to measure temperature. Measurements were done every 5 minutes, starting at 09:47 AM until 14:00 PM or 10:14 to 14:27 solar time. To give an overview of the dynamics of the

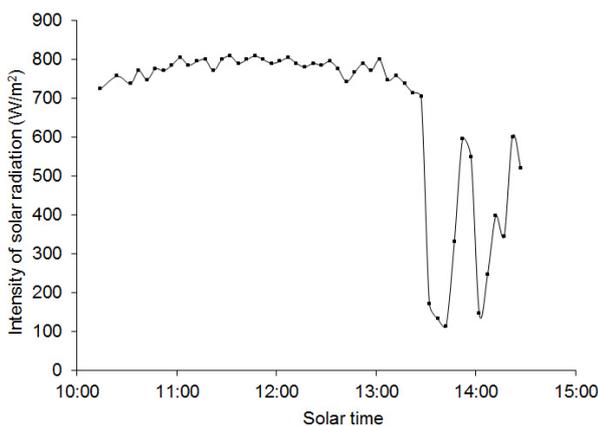
Figure 3. The Intensity of Received Solar Radiation

Weather conditions on the day of measurement. On the day of measurement, the weather was sunny in the morning until noon. Radiation intensity increased normally. From morning until 13:27, closing did not occur by the overcast sunlight. Starting at 13:32, overcast began blocking sunlight on site. However, it does not necessarily overcast preclude but come and go (Figure 3).

It can be concluded that when there is overcast then the radiation received decreases drastically [7]. This corresponds to previous research.

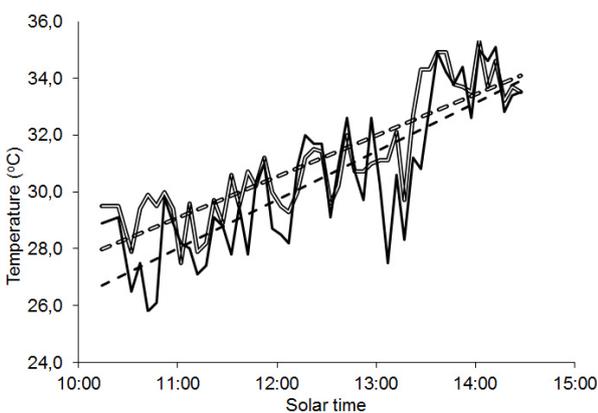
Figure 4. Surface Temperature of Fiber Cement Roof (—○) and Photovoltaic Modules Roof (—□), Trendline of Fiber Cement Roof Temperature (---○) and Trendline of Photovoltaic Modules Roof Temperature (---□)

The temperatures of fiber-cement roof and photovoltaic roof fluctuated with a tendency to increase (Figure 4). This increase is reasonable because the higher position of the sun increases the intensity of irradiation. At 13:32, when overcast began to blow, the temperature of fiber-cement roof fell fewer than the surface temperature of photovoltaic modules. The drop in temperature had only been for a moment because after that the radiation fluctuations occurred again and still dynamic.

Moreover, in essence, photovoltaic module temperature was lower than the surface temperature of fiber-cement roof. Trend lines from each curve give the assertion that, in general, the temperature of photovoltaic roof was lower than the temperature of the fiber-cement roof.

Calculation of average in between both of them also gave the same explanation. The average temperature of the fiber-cement roof was 31.1 °C, greater than the average surface temperature of photovoltaic modules, which was 30.4 °C. The value of the correlation between the two sets of temperature data was calculated for 0.87, which means that whenever there was an increase in temperature of fiber-cement roof, there was an increase in surface temperature of photovoltaic modules. Correlation numbers of 0.87 could be interpreted that the heating happened normally.

The fall in the intensity of sunlight did not necessarily lower the surface temperature of fiber-cement roof, but there was a pause (time lag). Decrease in temperature after a pause occurred in photovoltaic modules and in fiber-cement, but a longer time lag occurred in the fiber-cement roof. This was due to the thermal capacity from fiber-cement roof, which was higher than the thermal capacity of photovoltaic modules.

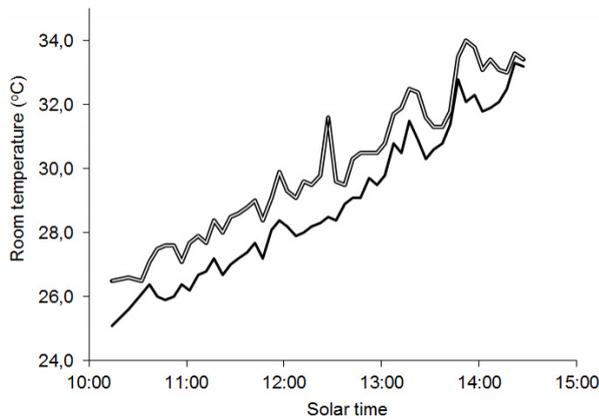
Room temperature. The experiment results also show that temperature of the room under the roof of photovoltaic was lower than room temperature under fiber-cement roof. This is consistent with the previous discussion, that the fiber surface temperature is higher than the surface temperature of photovoltaic modules. This is also strengthened by the thermal properties of corrugated fiber-cement i.e. U-value (6.10 W/m²K) [8], which is greater than U-value of photovoltaic modules glass (3.0 W/m²K) [8]. With this trend, it can be stated that the temperature of the room underneath is strongly influenced by surface temperature and thermal properties from each roofing material. Figure 5 provides the explanation.

Trend lines drawn from each of the curves confirm that the room temperature under the photovoltaic roof is colder than the room temperature under the fiber-cement roof. The difference is at the range of 1.1 to 1.2 °C at the same time.

Figure 5. Room Temperature under Fiber-cement Roof (—) and under Photovoltaic Modules Roof (---)
